EYEBAR REPAIR FACTSHEET

LABOR DAY WEEKEND, A CRACK WAS DISCOVERED IN A CRITICAL MEMBER OF THE ORIGINAL EAST SPAN

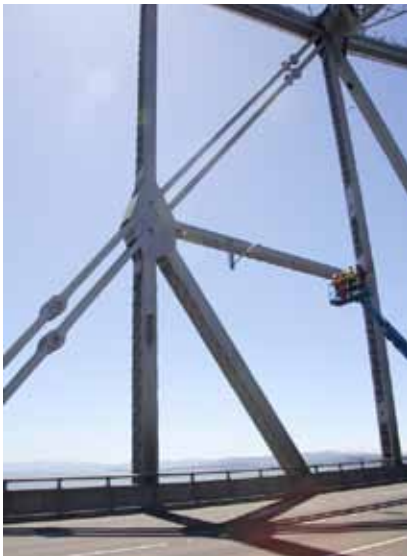
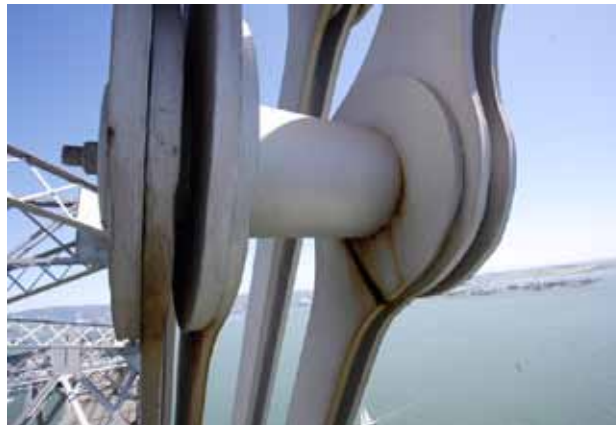
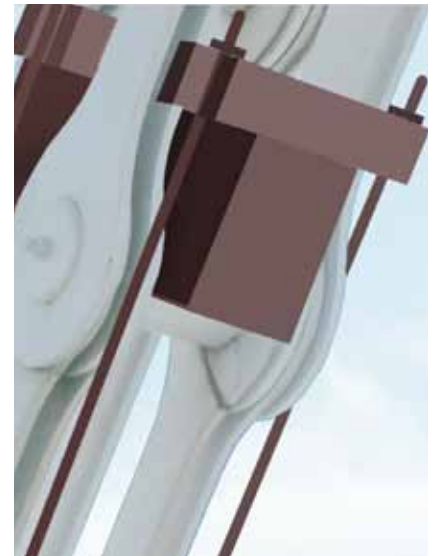
During the 2009 Labor Day weekend closure of the San Francisco-Oakland Bay Bridge, engineers inspecting the bridge discovered a crack in an eyebar, a critical piece of structural steel on the East Span.

Engineers found the damaged eyebar – one of 1,680 on the bridge – during a regularly scheduled inspection. Caltrans conducts thorough inspections every two years as mandated by federal law. The crack had occurred in the two years between inspections; rust in the crack indicated that it was not caused by the weekend's detour construction.

Workers and much of the material to fix the crack were already on site for the unrelated construction. Crews worked nearly 70 hours nonstop to repair the damaged eyebar.

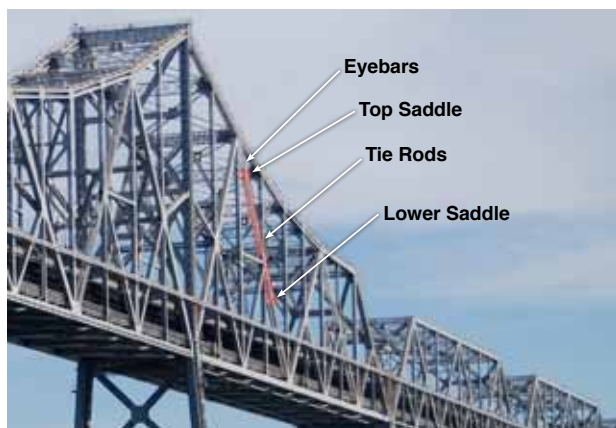
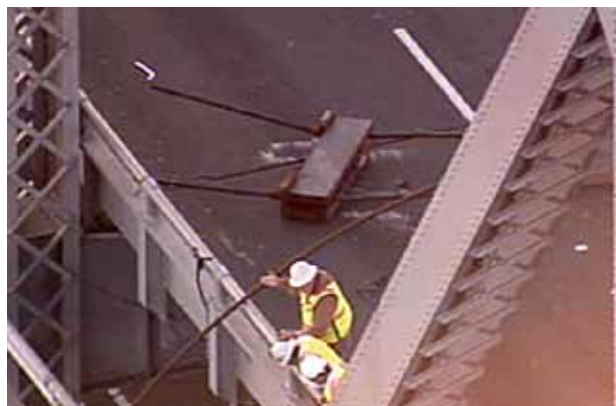
During the evening of Tuesday, Oct. 27, a high-strength tie rod failed, due to fatigue-stress, most likely caused by excessive movement of the rod during high-winds resulting in metal-on-metal contact.

The failed tie rod pulled down another tie rod and a steel cross bar from the top saddle which fell onto the upper deck of the Bay Bridge. Caltrans immediately closed the Bay Bridge and began designing repairs.
